# RCRA FACILITY ASSESSMENT REPORT CALGON CORPORATION PASADENA, TEXAS TXD086476850

# U.S. ENVIRONMENTAL PROTECTION AGENCY Region 6 1445 Ross Avenue Dallas, TX 75202

PRC Environmental Management, Inc. 350 North St. Paul Suite 2600 Dallas, TX 75201

February 18, 1993

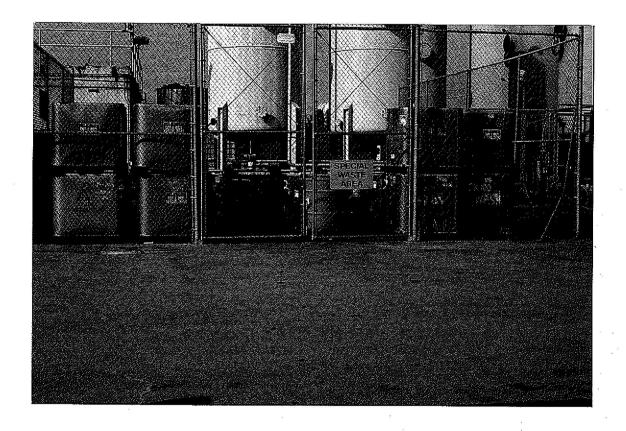
Date: <u>12/01/92</u> Location: <u>SWMU No. 1</u>

Description: The special waste storage area stores hazardous and nonhazardous wastes for less than 90 days.

PRC recommends no further investigation for this SWMU.

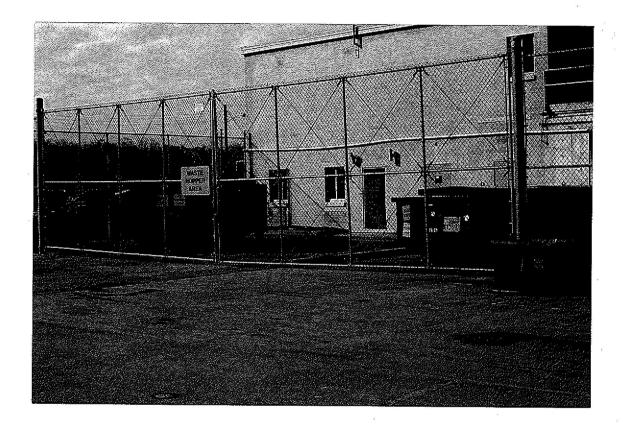
Bulk storage area; note the two roll-off containers used for storage.

PRC recommends no further investigation for this SWMU.

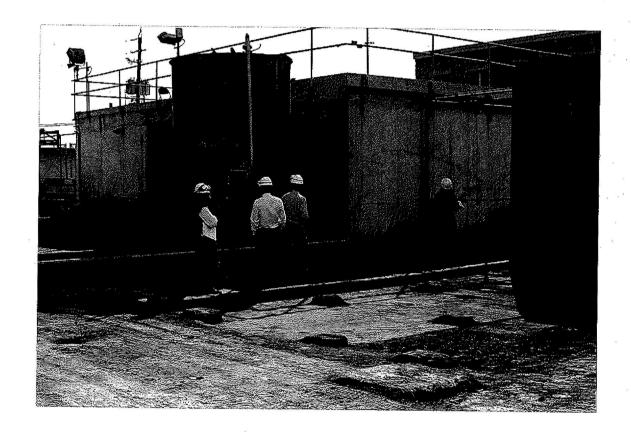
Date: <u>12/01/92</u> Location: <u>SWMU No. 3</u>

North Location: <u>SWMU No Inactive concrete sumps that were used for spent and regenerated carbon storage</u>

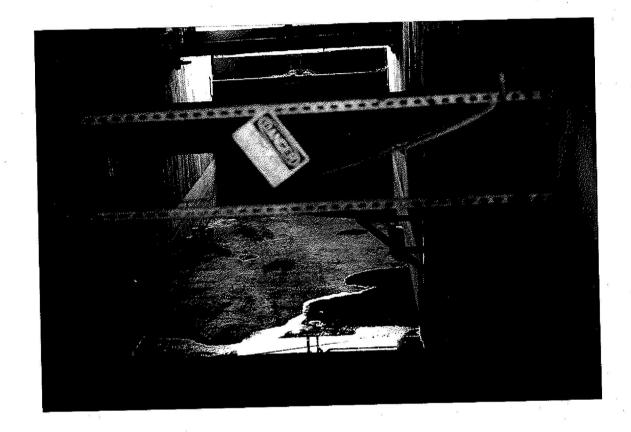
Date: <u>12/01/92</u> Location: <u>SWMU No. 3</u>

Orientation: South
Description: View of the carbon sumps from inside the react building

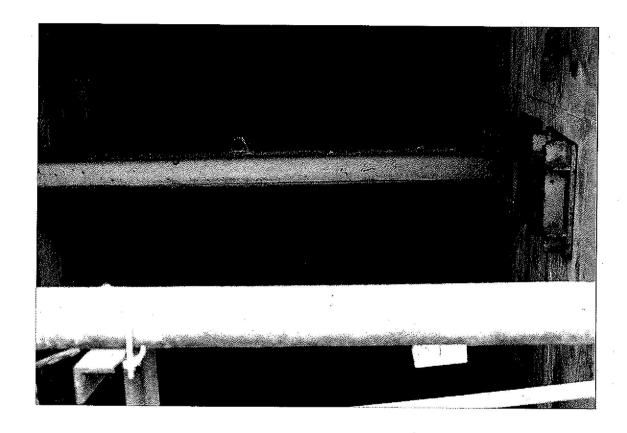
Location: SWMU No. 3

East
View of the carbon sumps from outside of the react building Description:

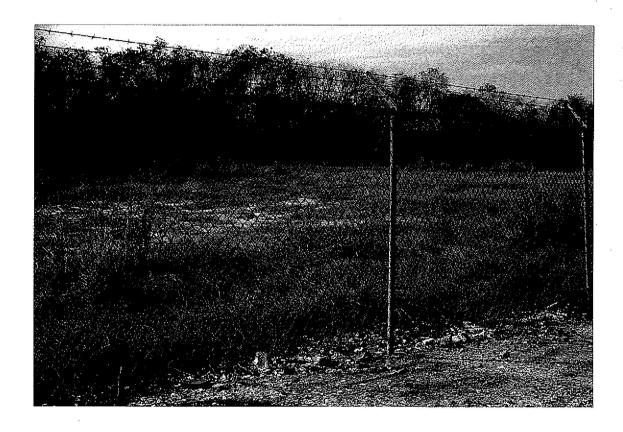
Northwest Location: SWMU No. 4
Spent carbon storage pit; note that the pit is located outside of the property fence. Description:

PRC recommends an RFI for this SWMU.

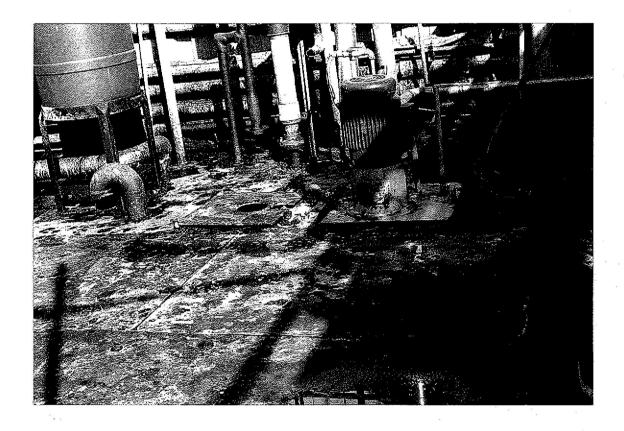
Date: 12/01/92 Location: <u>SWMU No. 5</u>

The three blend process sumps are located in the pretreatment process area. According to facility diagrams, the sumps are constructed out of concrete. The southeast and southwest sumps are 9 by 9 by 8 feet and have a capacity of 10,000 gallons. The north sump is 22 by 8 by 8 feet and has a capacity of 20,000 gallons. During the VSI, PRC observed waste contamination on the concrete surface of the sumps.

West Blend process sump

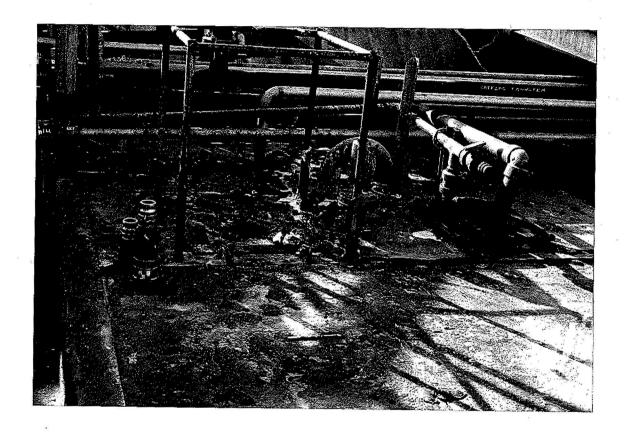
Date: 12/01/92 Location: <u>SWMU No. 5</u>

West Blend process sump

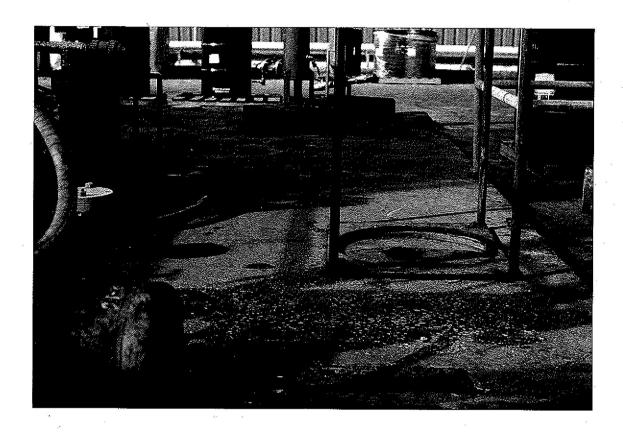
Date: 12/01/92 Location: <u>SWMU No. 5</u>

West Blend process sump

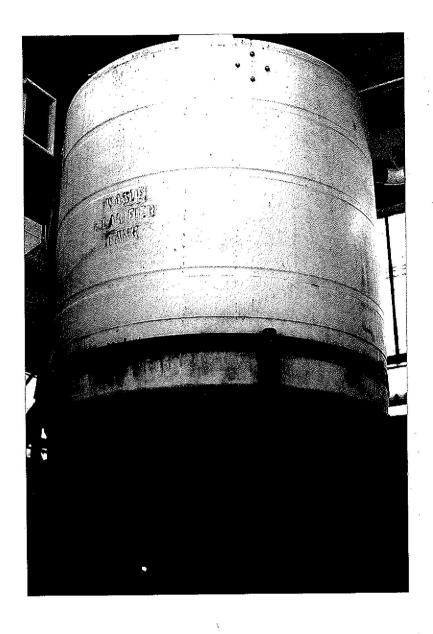
West Location: SWMU No. 6
Clarifier tank located in the pretreatment area with a capacity of 3,000 gallons Description:

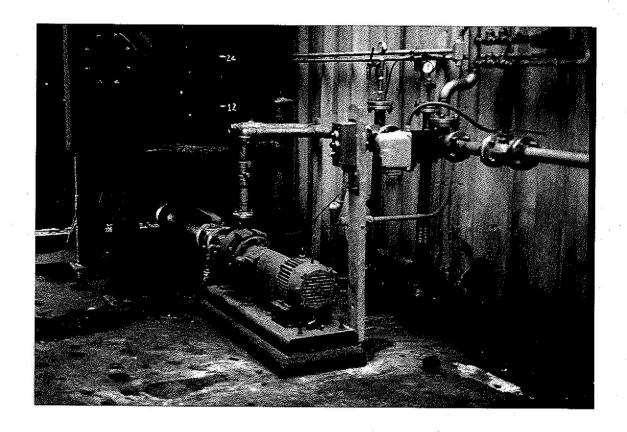
Date: <u>12/01/92</u> Location: <u>SWMU No. 6</u>

The clarifier tank is located inside the pretreatment building on a concrete floor. The 3000-gallon-capacity tank is used to adjust the pH of effluent and settle solids prior to discharge to the POTW. A floor drain that discharges to the blend process sumps (SWMU No. 5) is located in the building to contain any wastewater spills. Spills would flow to the floor drain, then to a blend process sump. They would ultimately be discharged back into the pretreatment process. During the VSI, PRC observed stains on the concrete floor inside the pretreatment area (Photograph No. 11).

West Loca Concrete floor in the pretreatment area; note stains on the floor.

PRC recommends no further investigation for this SWMU.

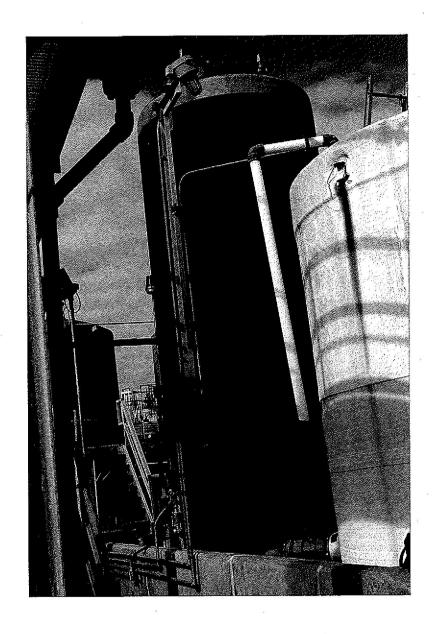
Date: <u>12/01/92</u> Location: <u>SWMU No. 7</u>

North Chromate waste tank

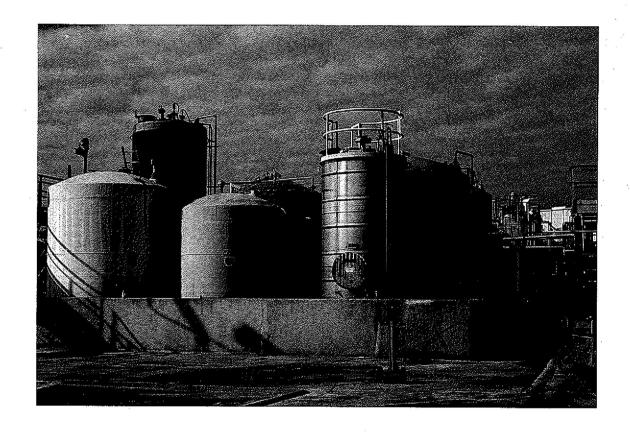
The chromate waste tank and the concrete containment dike are in good condition; the unit is inactive.

North Location: SWMU No. 7
Chromate waste tank in the product tank farm; note the 4-foot-high concrete dike.

PRC recommends no further investigation for this SWMU.

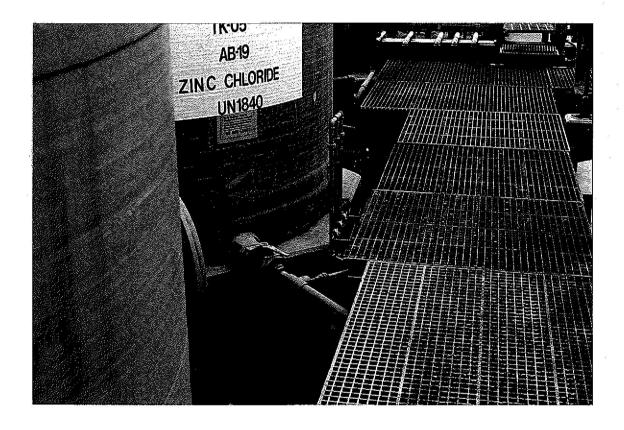
Date: <u>12/01/92</u> Location: <u>SWMU No. 7</u>

The chromate waste tank, constructed of fiberglass, is located in the product tank farm on the east side of the property. The tank is 7-1/2 feet in diameter and 19 feet 5 inches high, with an elliptical roof. The capacity of the tank is 6,000 gallons. The concrete containment basin of the tank farm is about 45 by 38 feet, and a 4-foot-high concrete containment dike surrounds the tank farm. During the VSI, 6 to 12 inches of rainwater were observed standing inside the tank farm containment dike.

South Standing water in the product tank farm

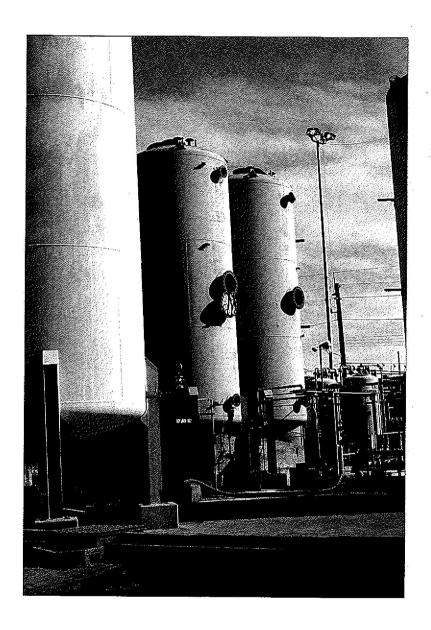
Date: <u>12/01/92</u> Location: <u>SWMU No. 8</u>

The concrete secondary containment is in good condition. The tanks have been clean closed for use as hazardous waste units, and TWC approved clean closure in 1989.

Closed spent carbon storage tanks

PRC recommends no further investigation for this SWMU.
